NEW YORK STATE SUPERFUND CONTRACT

PRELIMINARY AGREEMENT
(SITE INVESTIGATION)
REPORT

New Cassel Industrial Area Site
North Hempstead, Nassau County

Site No. 130043

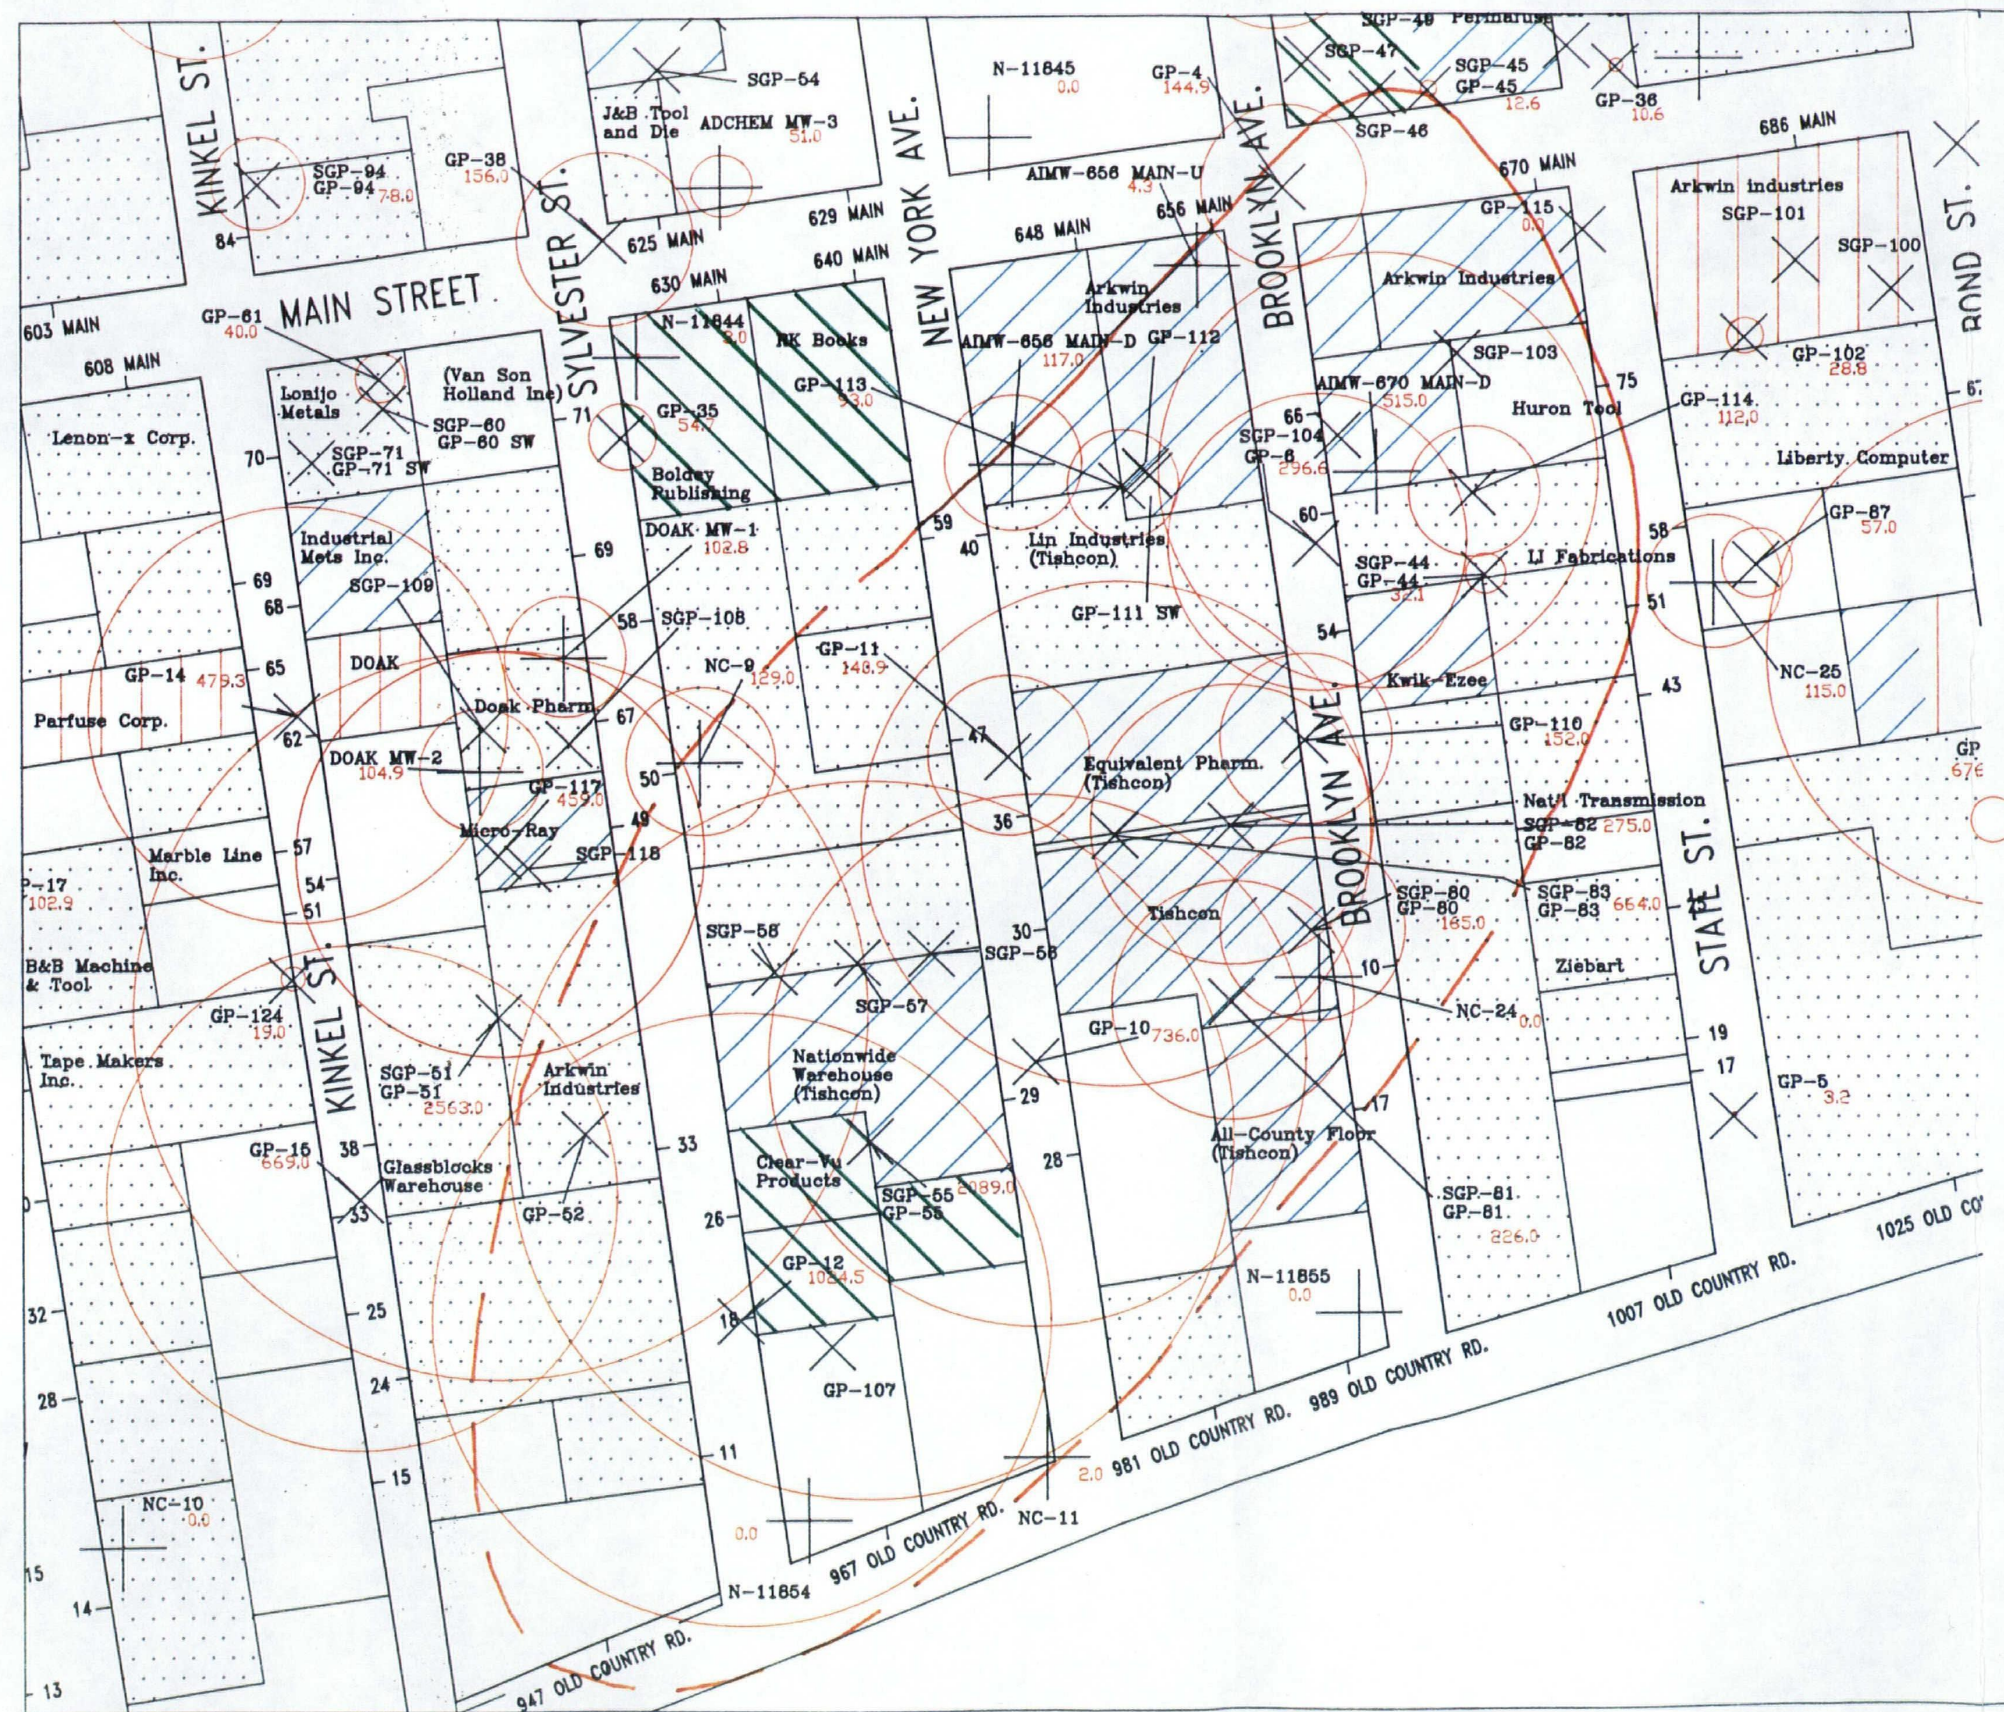
FIGURE 6.11
ARKWIN-TISHCON
CENTRAL SECTION - NCIA
PCE PLUME
55-75 ft DEPTH
LAWLER, MATUSKY & SKELLY ENGINEERS
Pearl River, New York

Proportional representation of
total detected concentrations
of PCE+TCE+DCE's+VC in
micrograms per liter (ug/l).

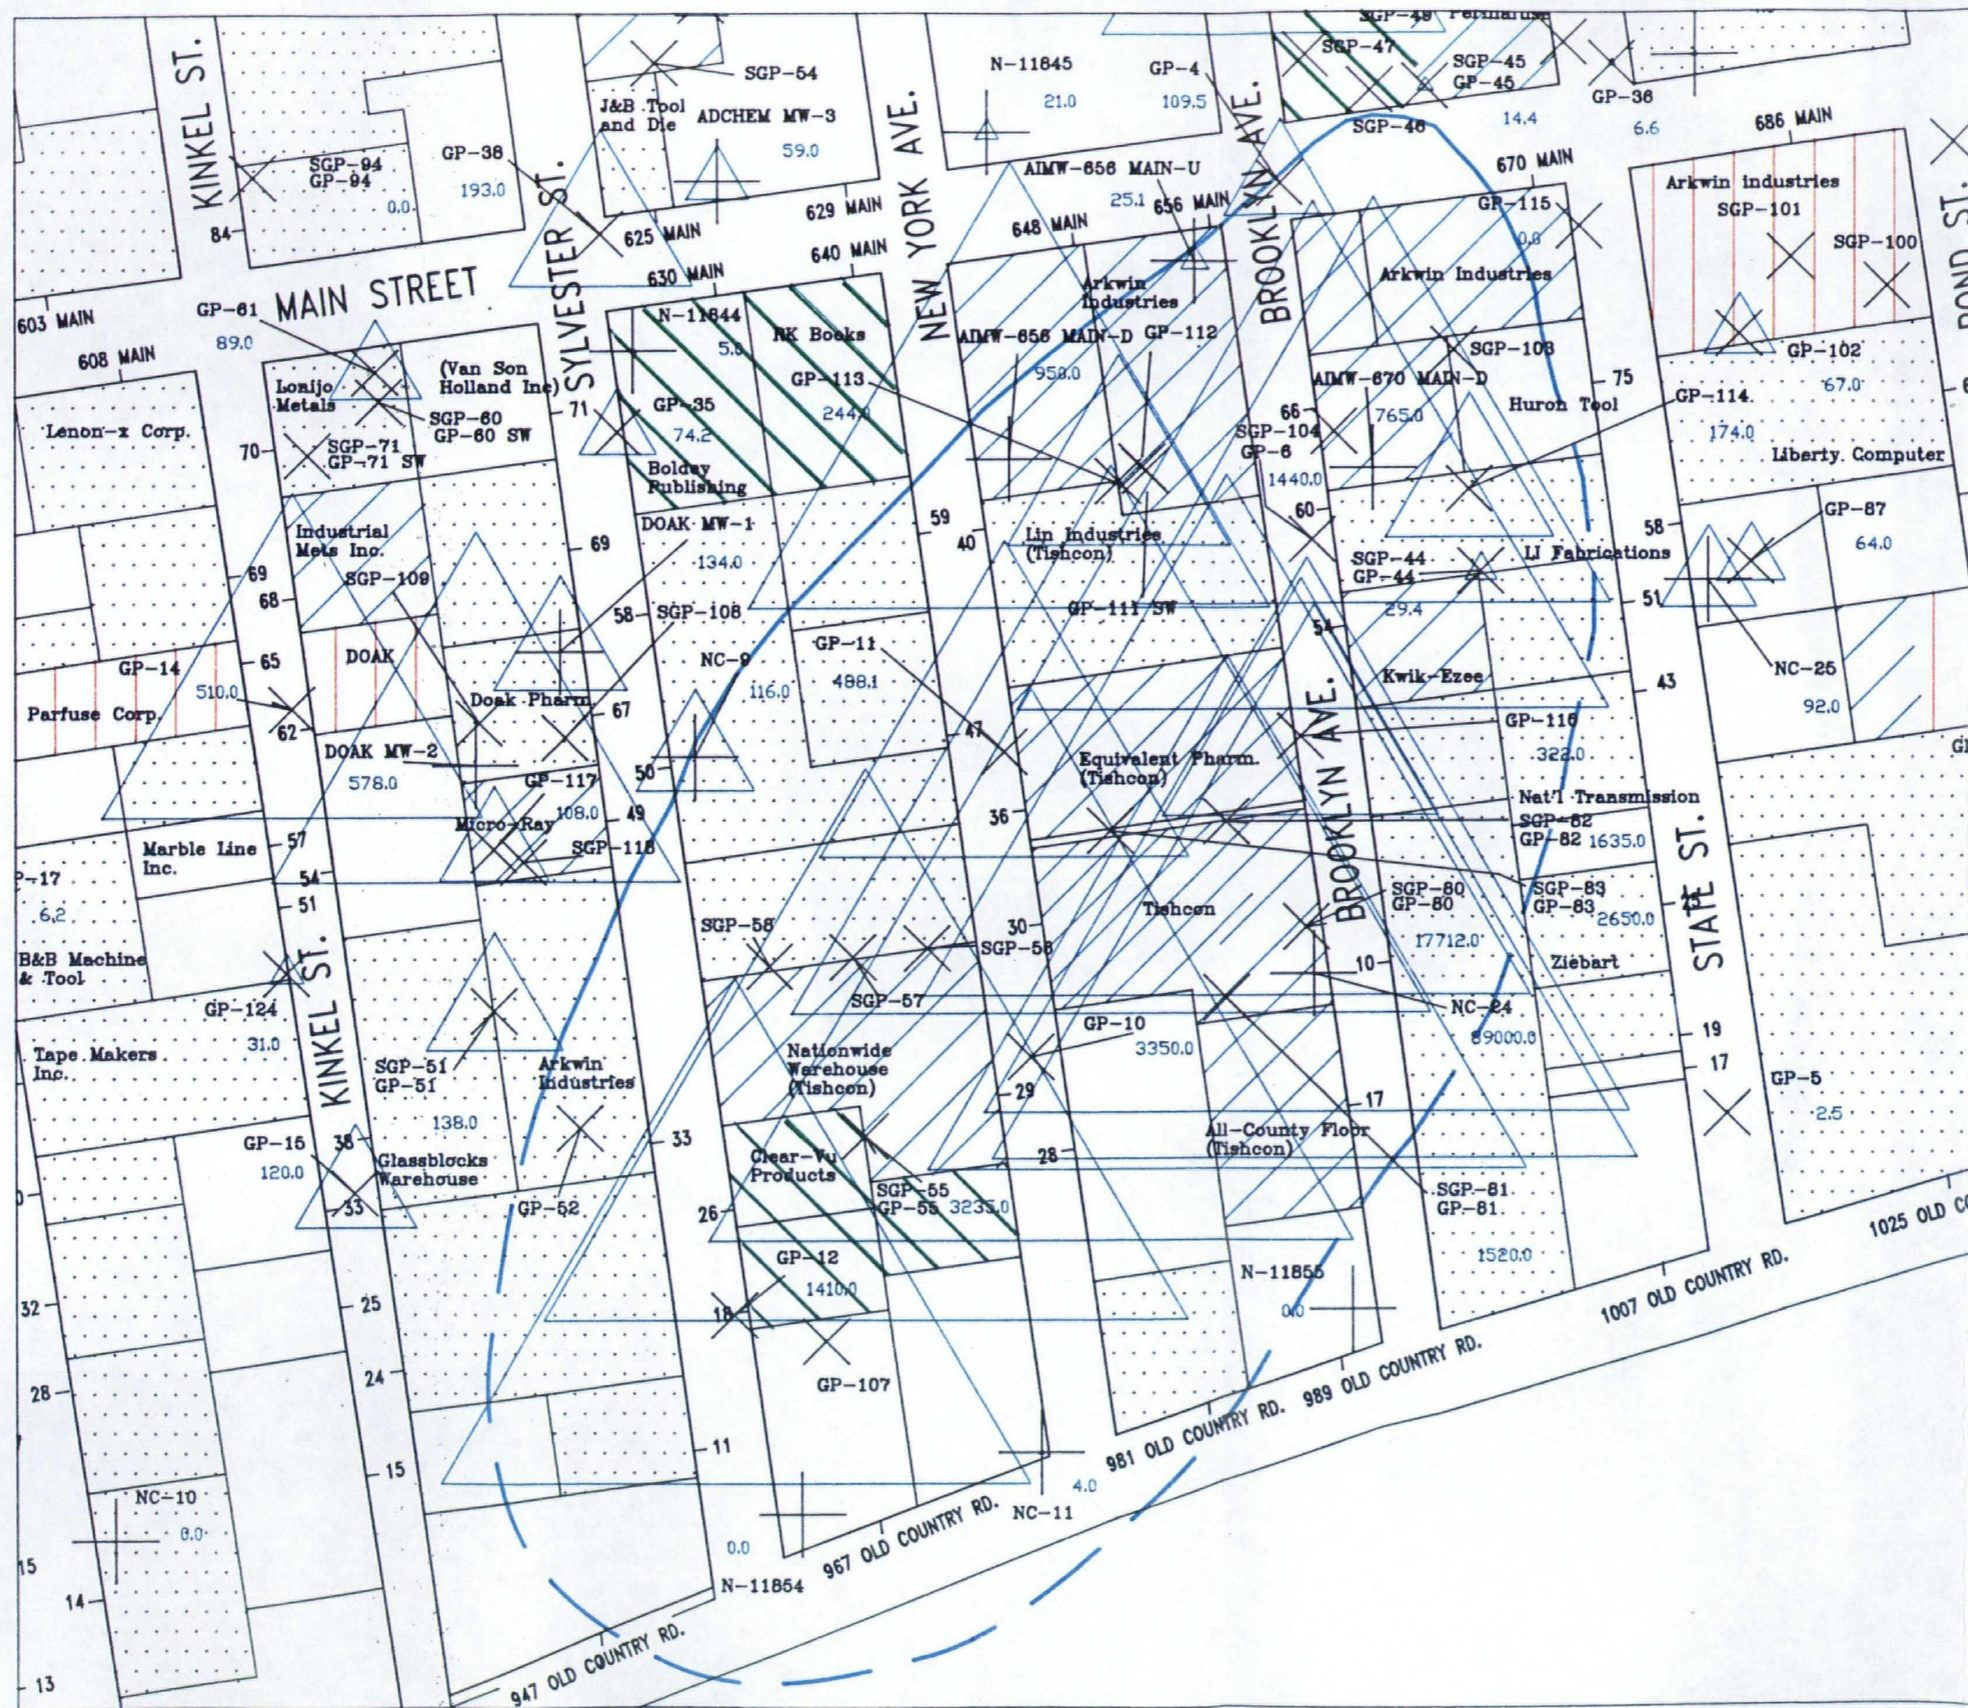
FIGURE 6.12
ARKWIN-TISHCON
CENTRAL SECTION - NCIA
1,1,1-TCA PLUME
55-75 ft DEPTH
LAWLER, MATUSKY & SKELLY ENGINEERS
Pearl River, New York

Proportional representation of
total detected concentrations
of 1,1,1-TCA+DCA's in
micrograms per liter (ug/l).

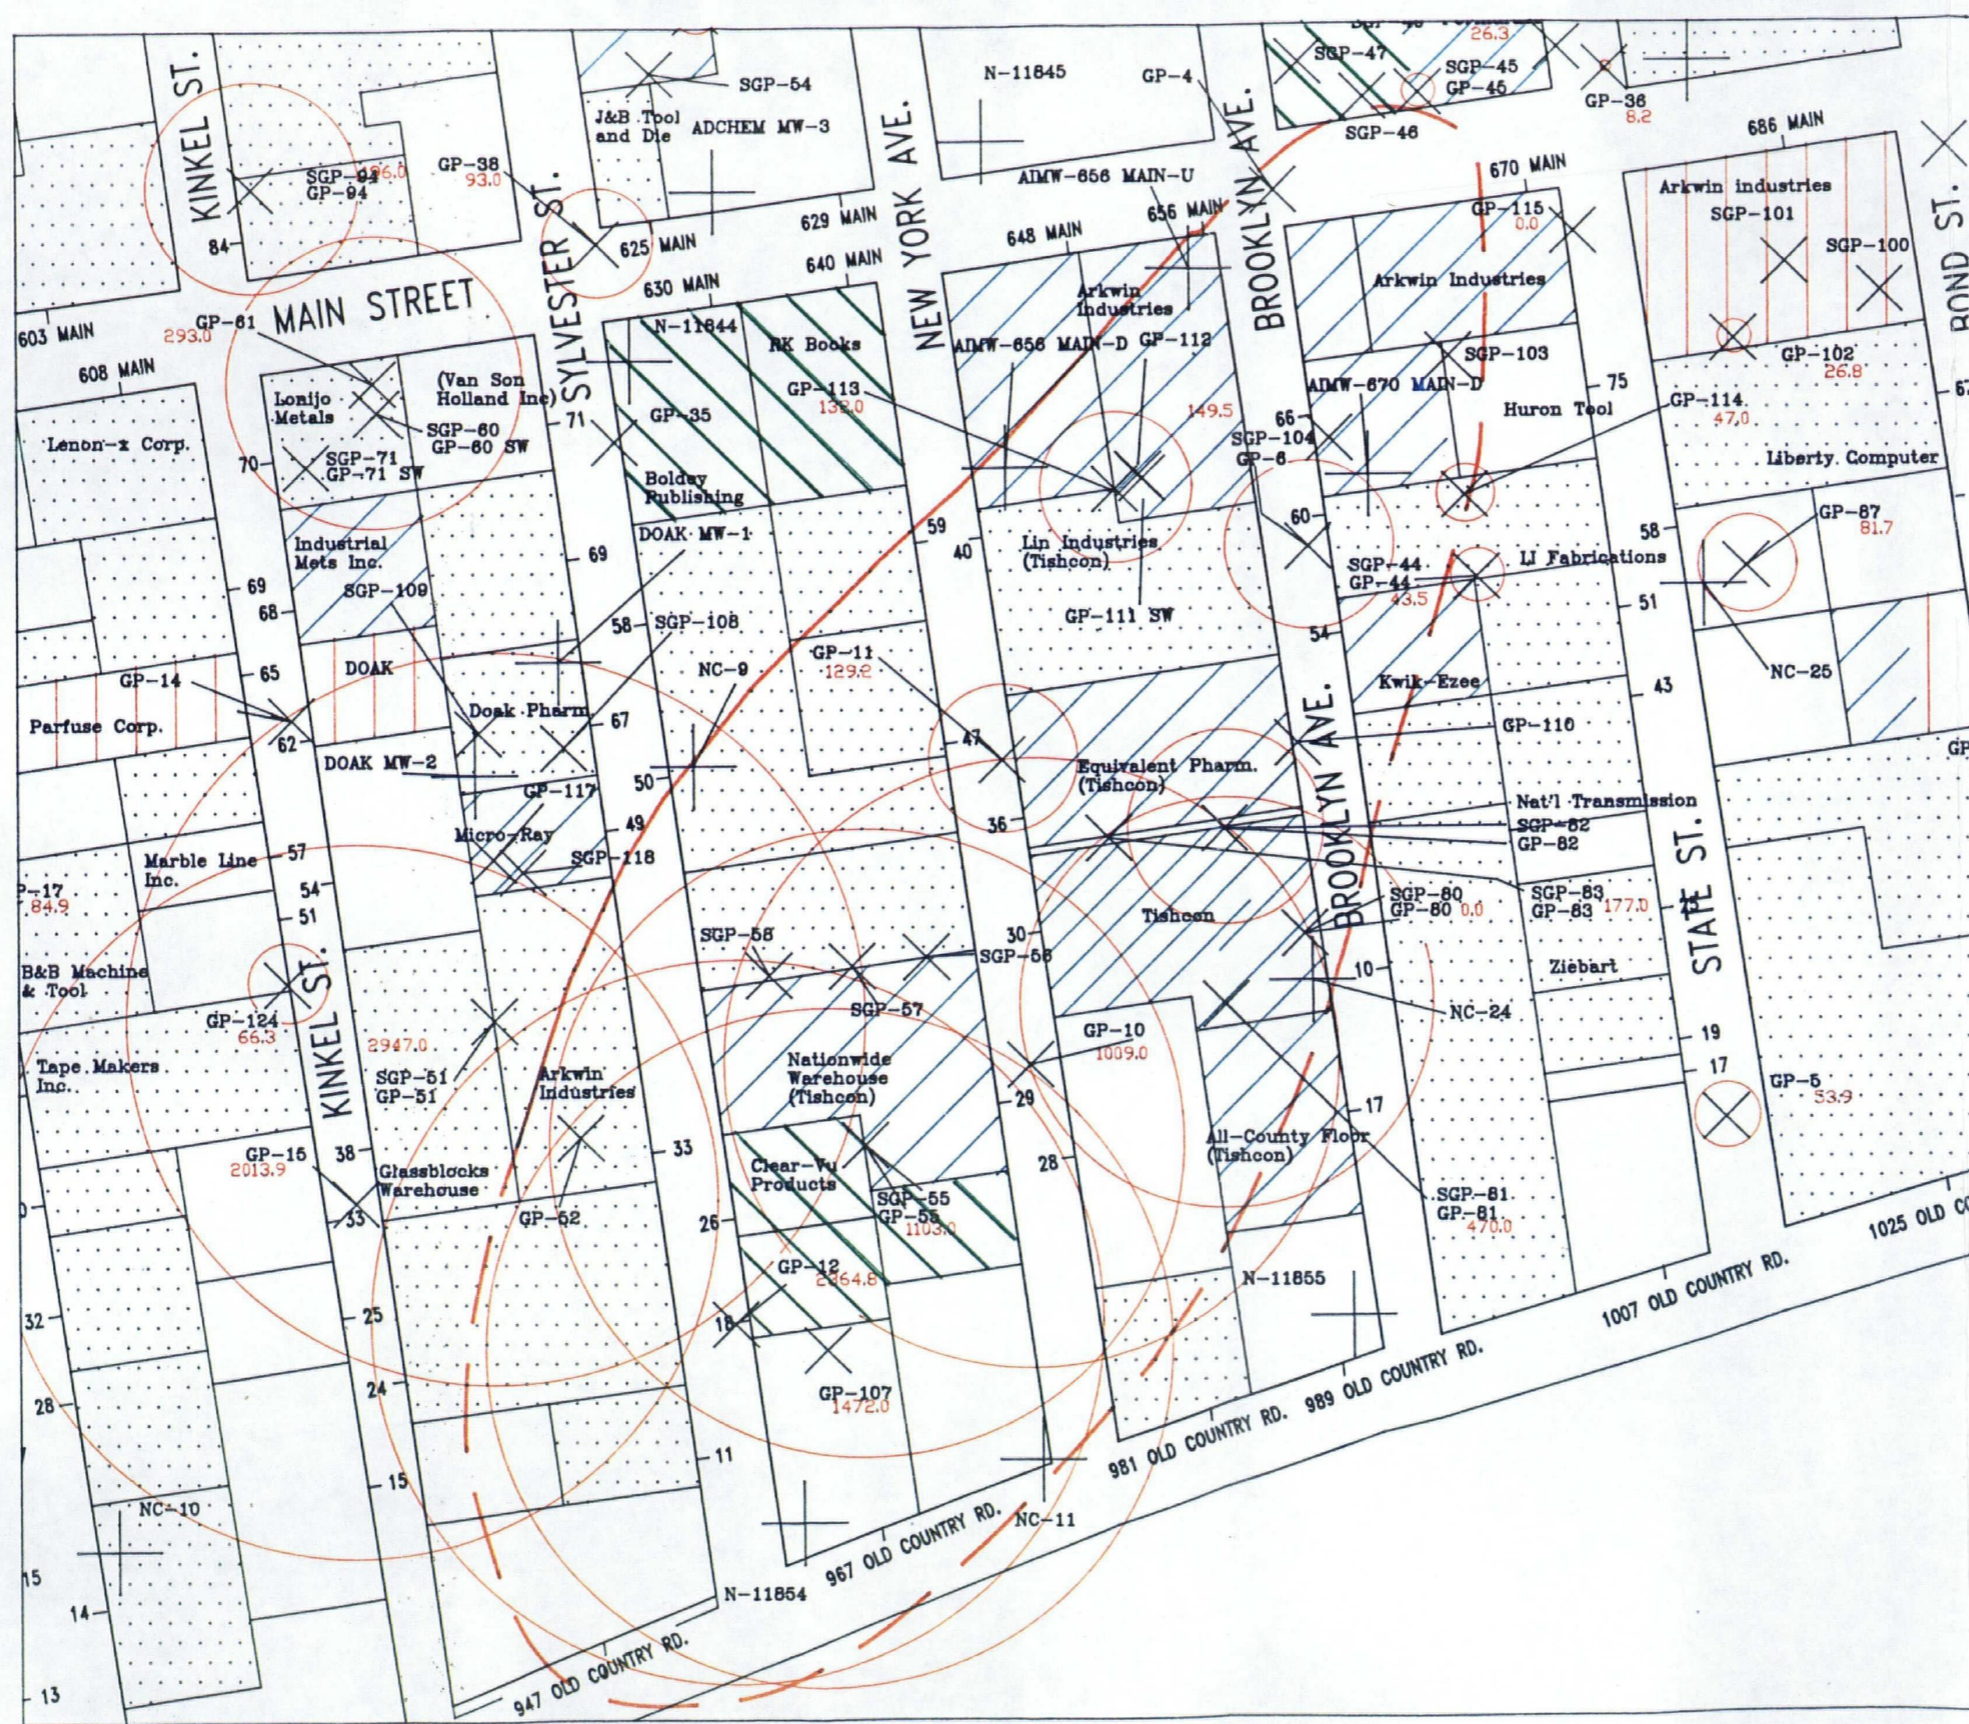
FIGURE 6.13
ARKWIN-TISHCON
CENTRAL SECTION - NCIA
PCE PLUME
75-85 ft DEPTH
LAWLER, MATUSKY & SKELLY ENGINEERS
Pearl River, New York

○ Proportional representation of total detected concentrations of PCE+TCE+DCE's+VC in micrograms per liter (ug/l).

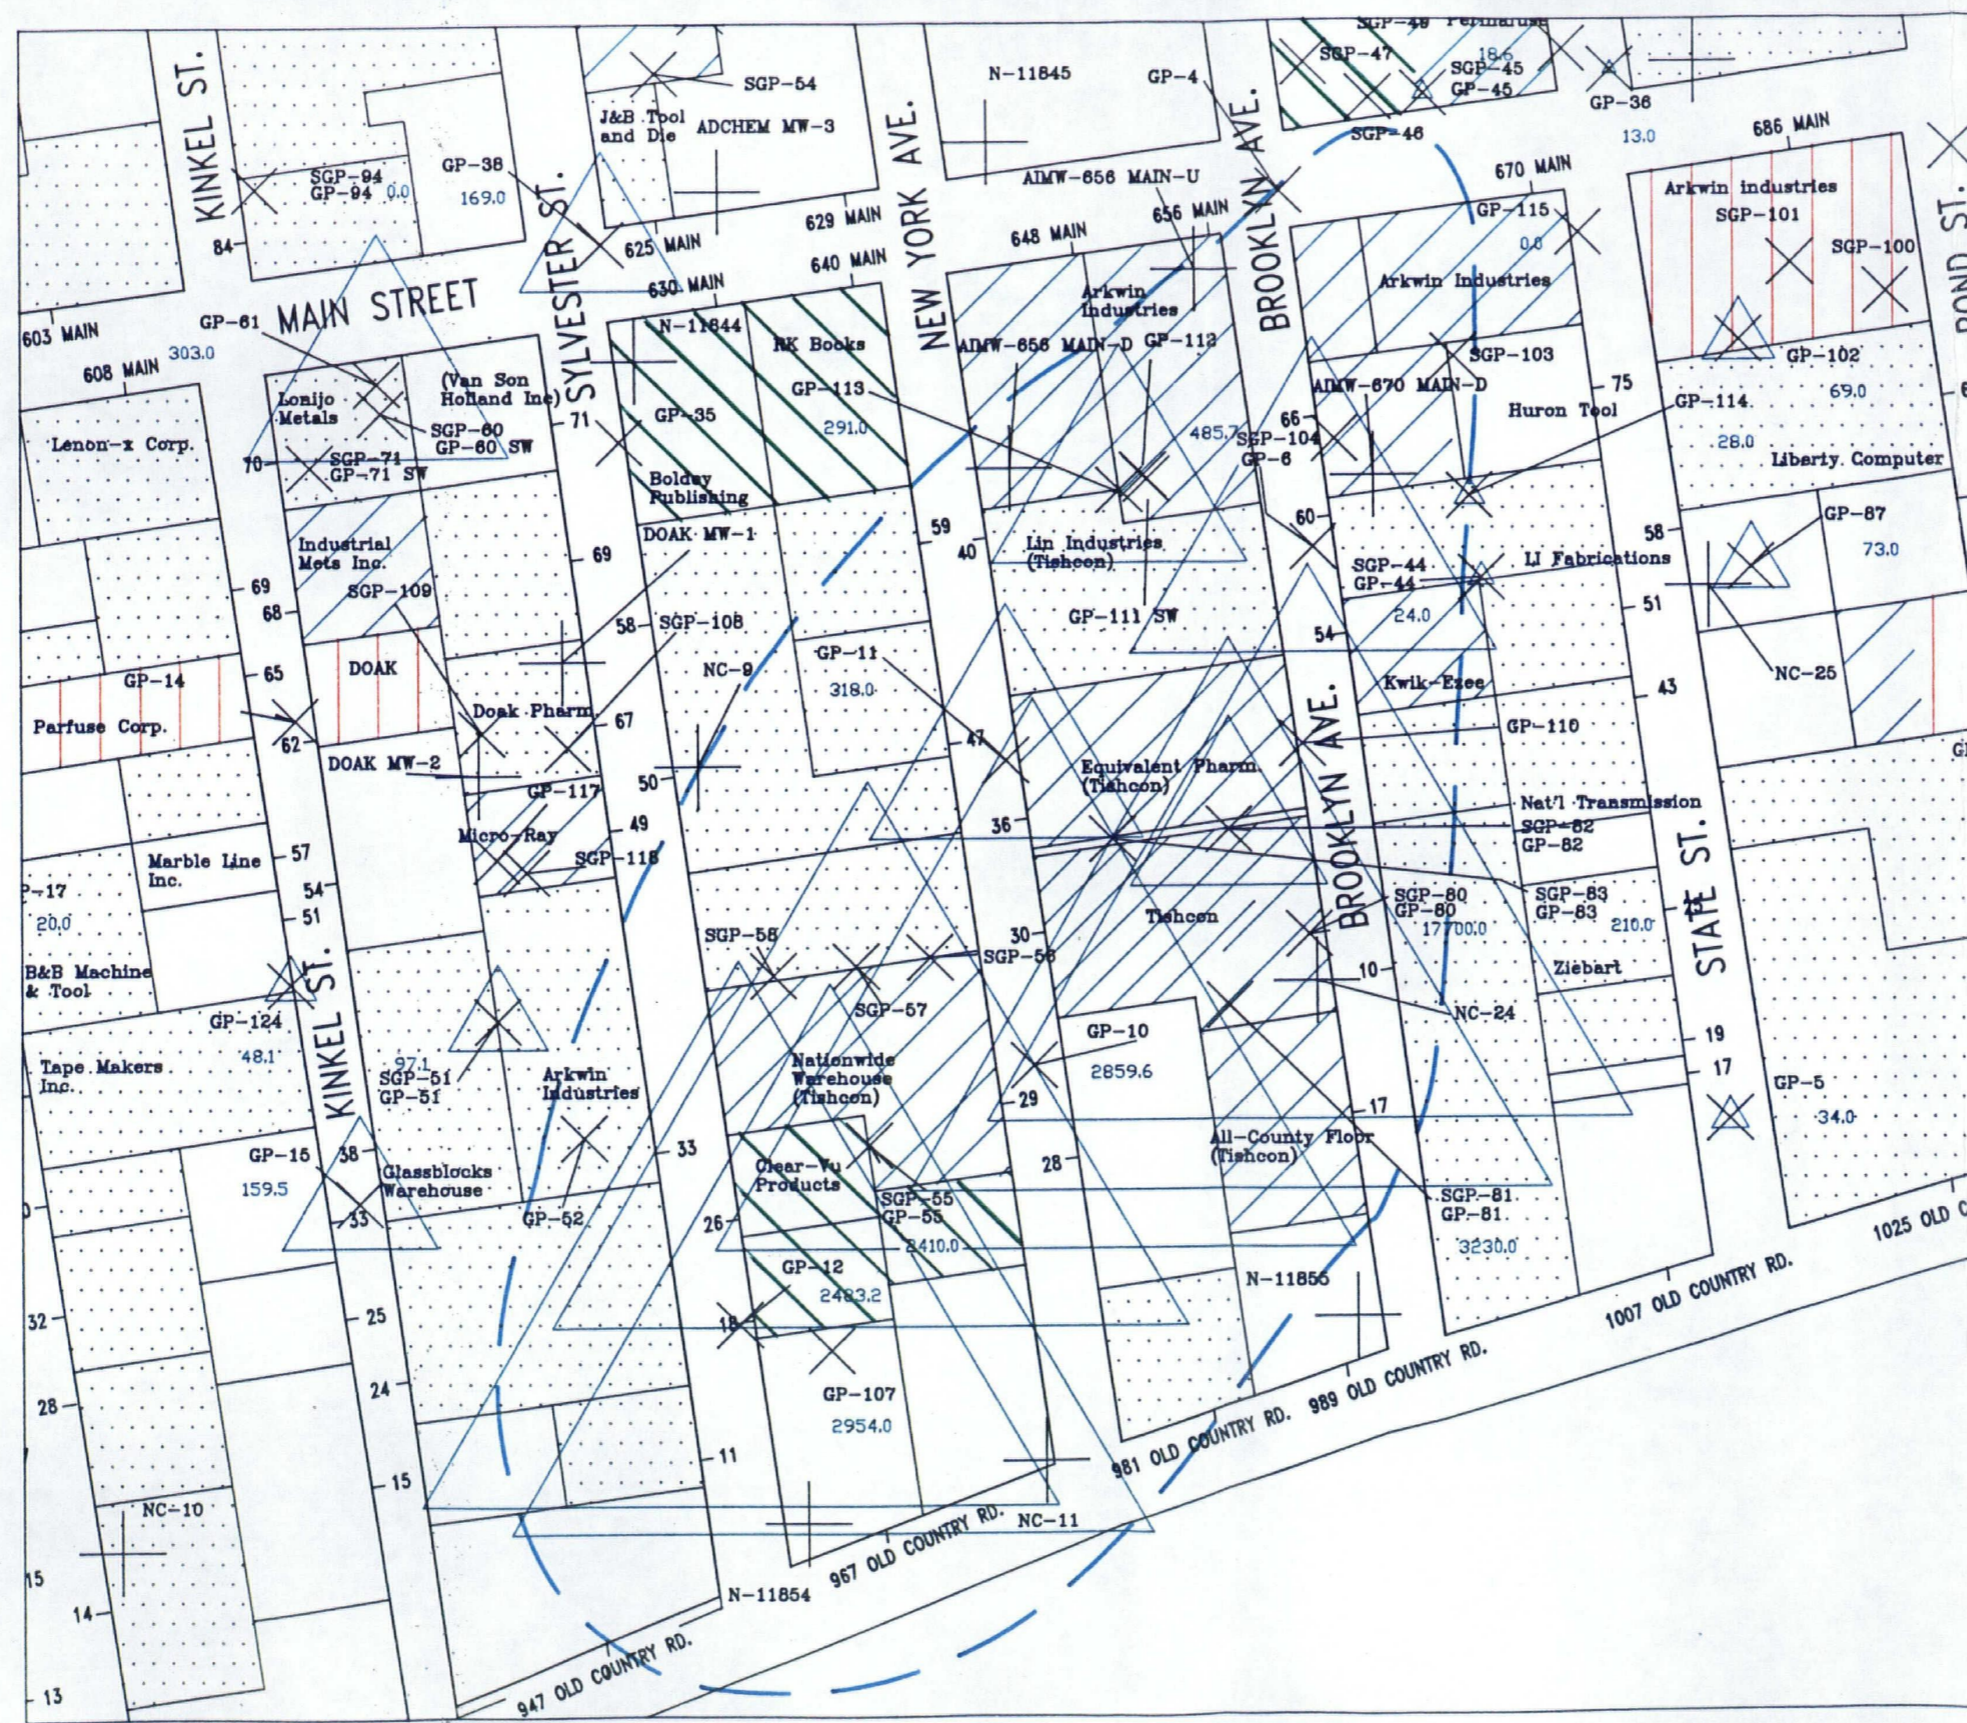
FIGURE 6.14
ARKWIN-TISHCON
CENTRAL SECTION - NCI
1,1,1-TCA PLUME
75-85 ft DEPTH
LAWLER, MATUSKY & SKELLY ENGINEERS
Pearl River, New York

Proportional representation of
total detected concentrations
of 1,1,1-TCA+DCA's in
micrograms per liter (ug/l).

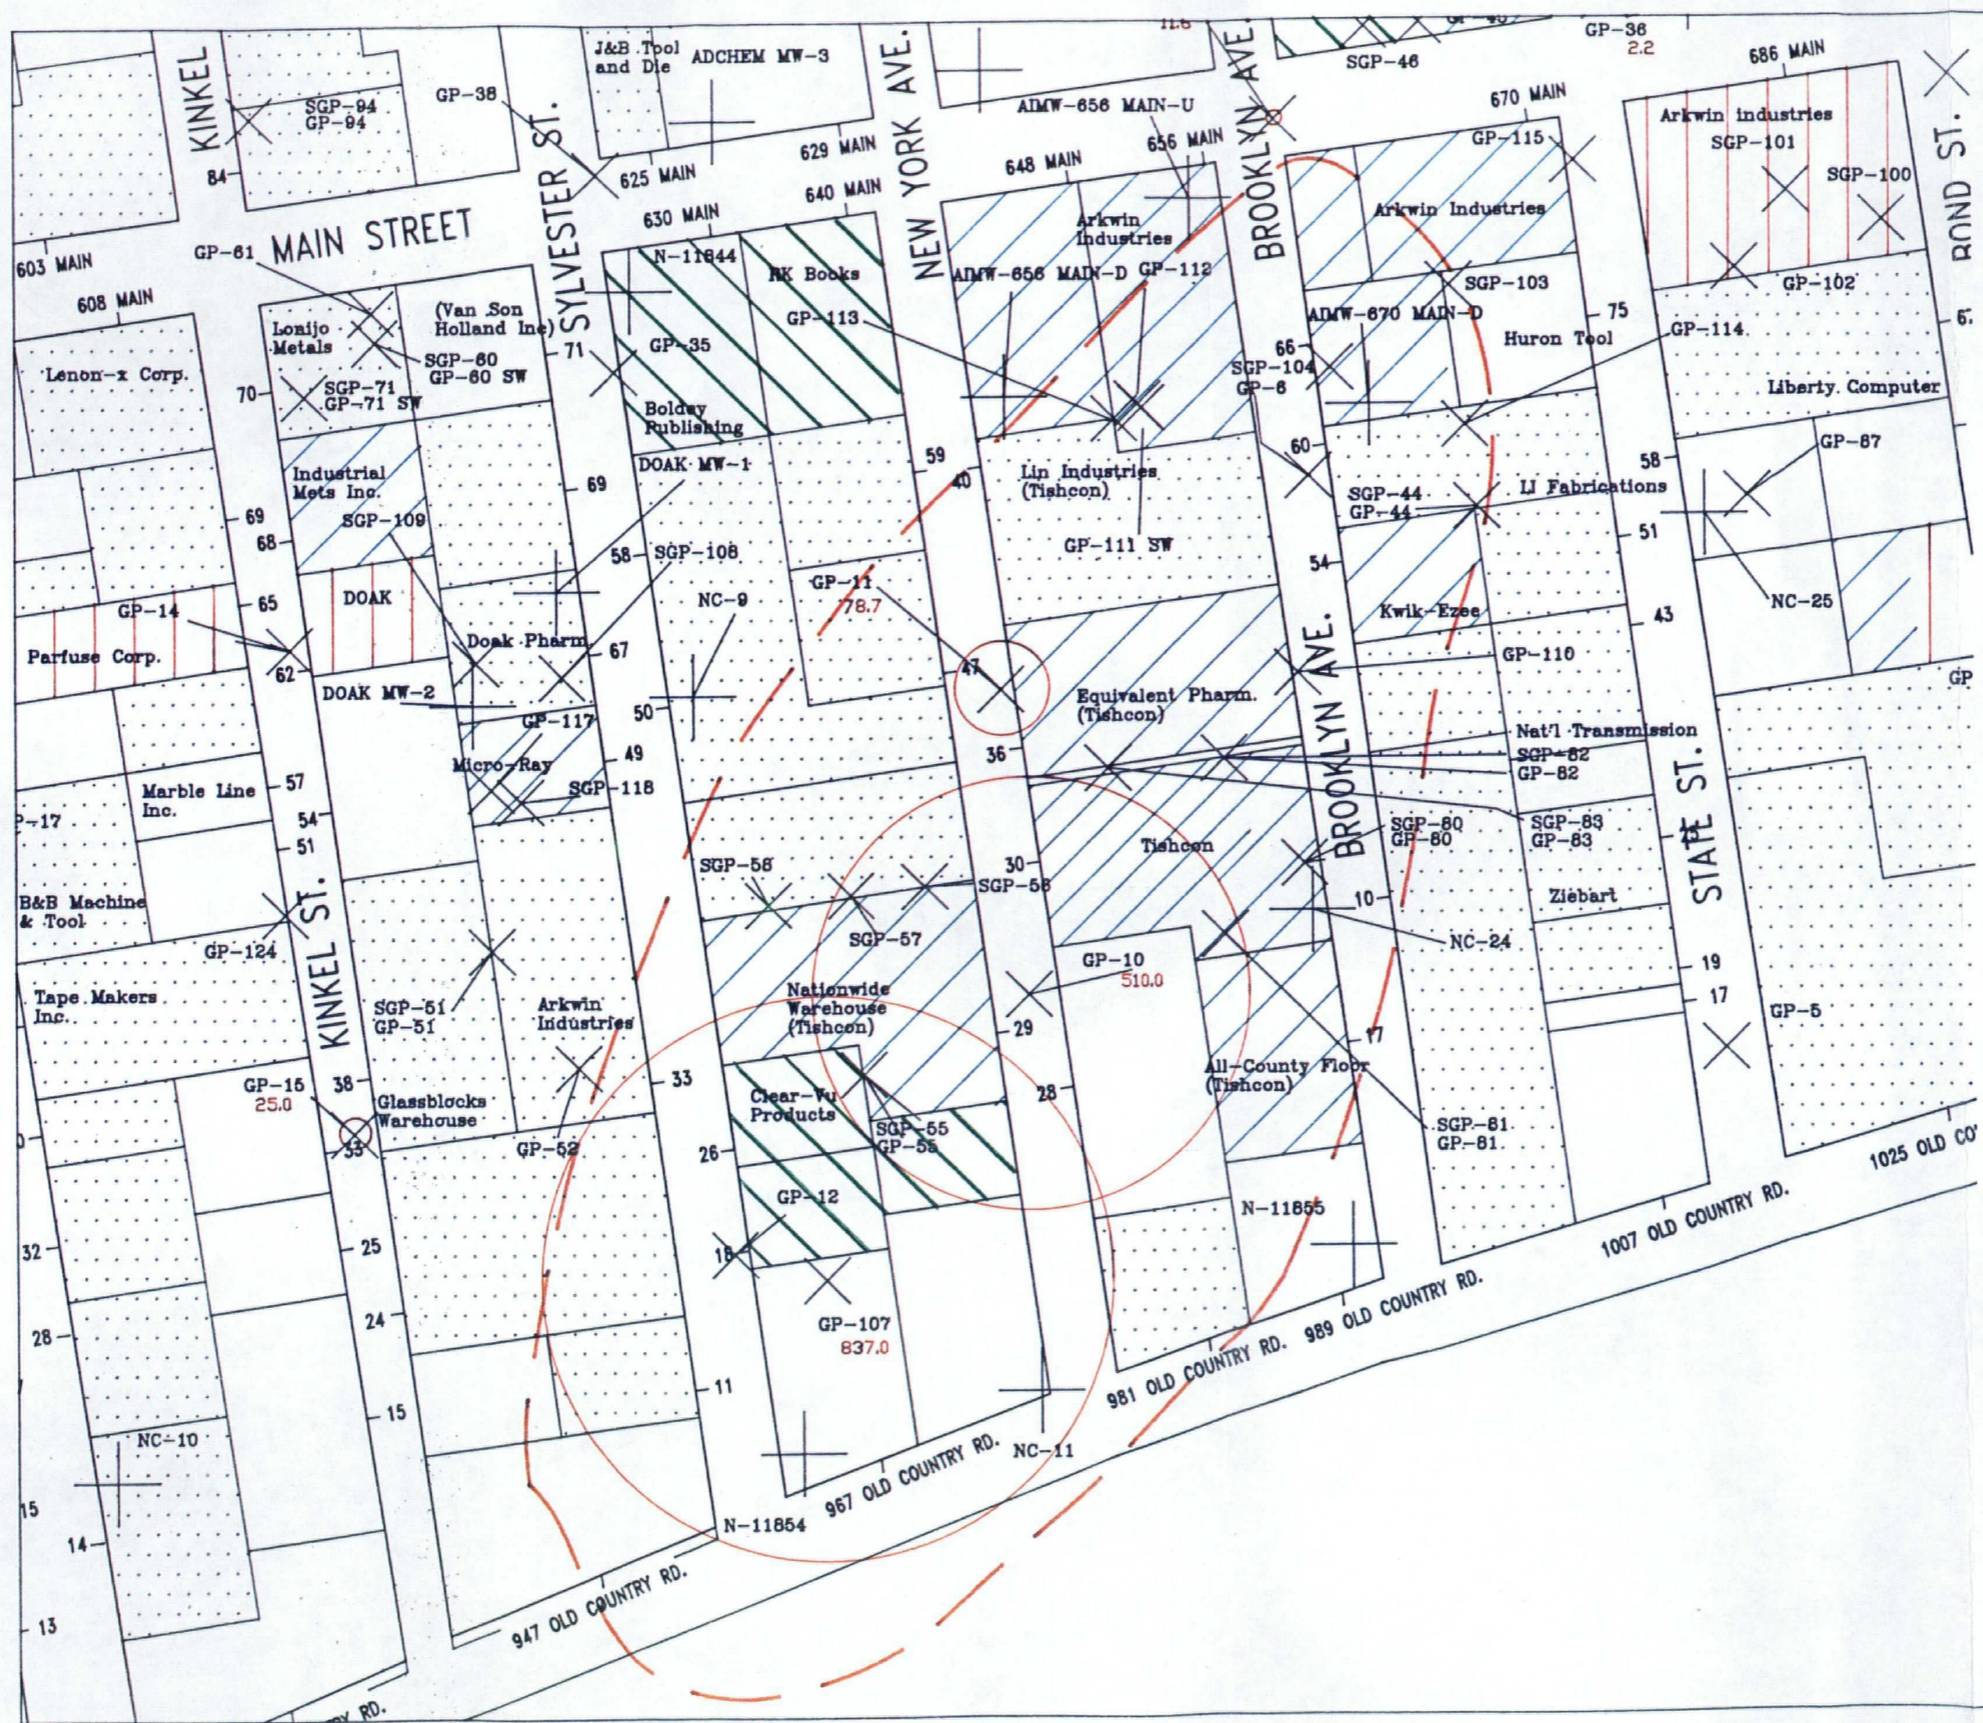
FIGURE 6.15
ARKWIN-TISHCON
CENTRAL SECTION - NCIA
PCE PLUME
85-95 ft DEPTH
LAWLER, MATUSKY & SKELLY ENGINEERS
Pearl River, New York

Proportional representation of total detected concentrations of PCE+TCE+DCE's+VC in micrograms per liter (ug/l).

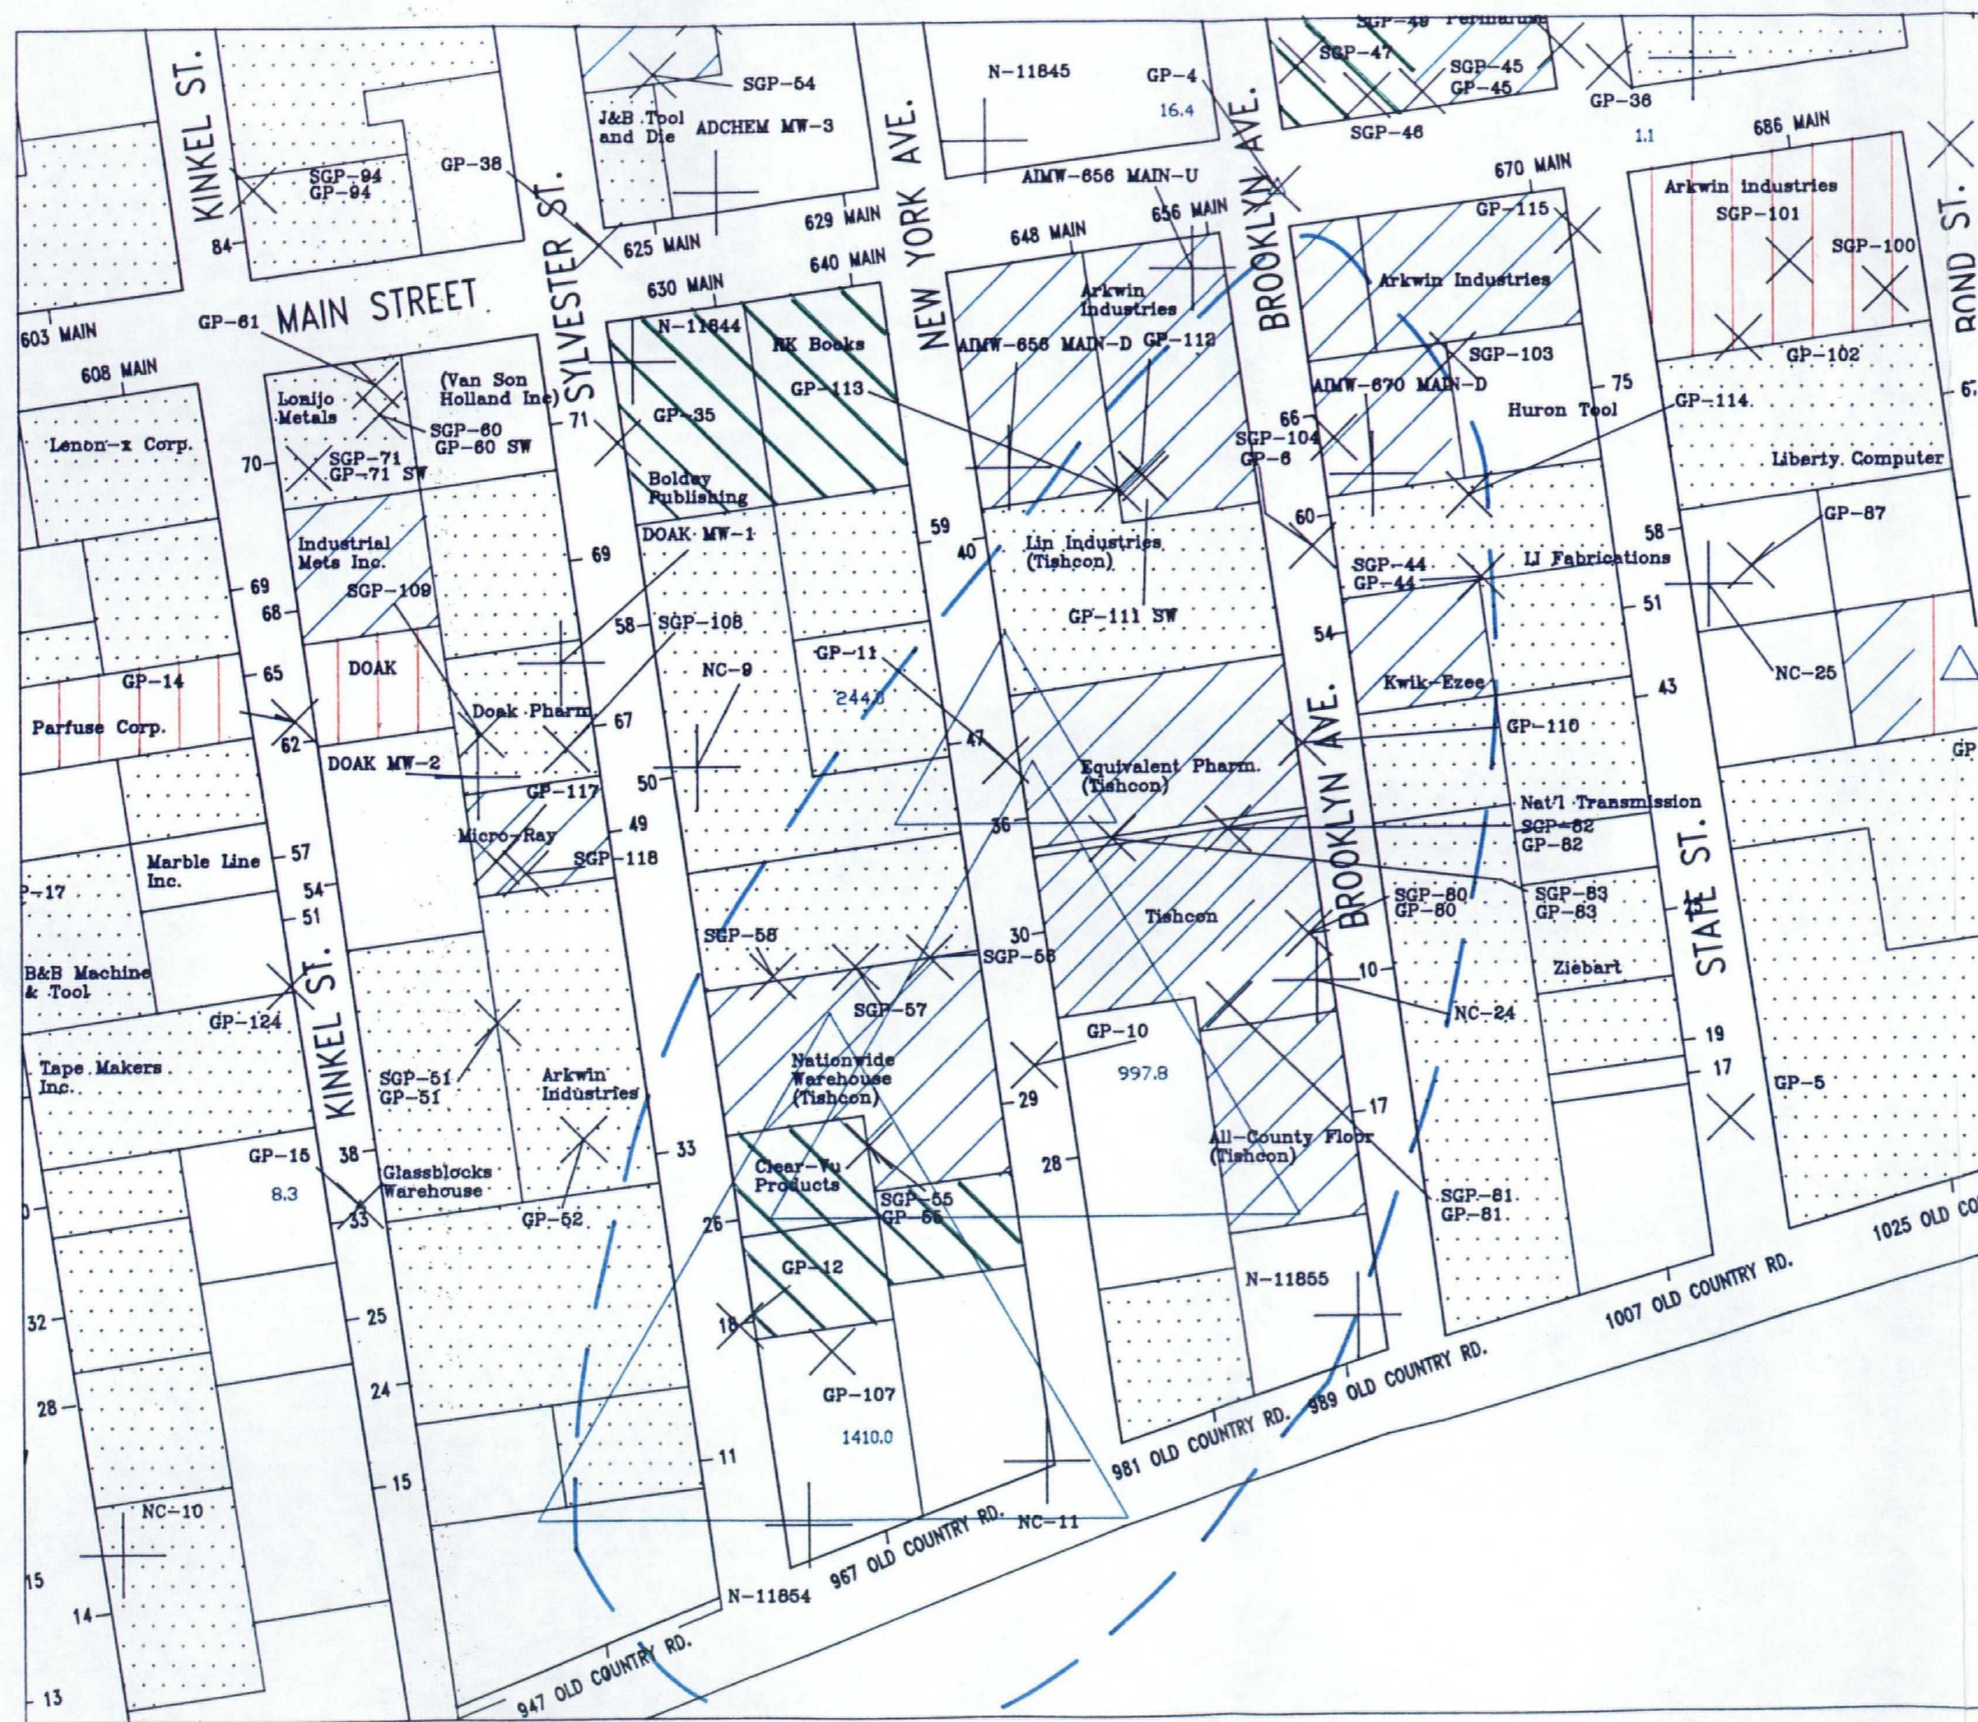
FIGURE 6.16
ARKWIN-TISHCON
CENTRAL SECTION - NCIA
1,1,1-TCA PLUME
85-95 ft DEPTH
LAWLER, MATUSKY & SKELLY ENGINEERS
Pearl River, New York

Proportional representation of
total detected concentrations
of 1,1,1-TCA+DCA's in
micrograms per liter (ug/l).
